Manhole Inspection Summary

Manhole # S37GG1012MH

Insp Date: **1/9/07 1:46 PM**

Location Address: **526 ENGLE AVE**

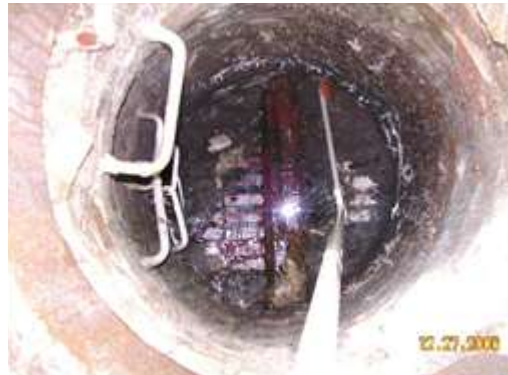
Top View

Evidence of surcharge - Bench debris.

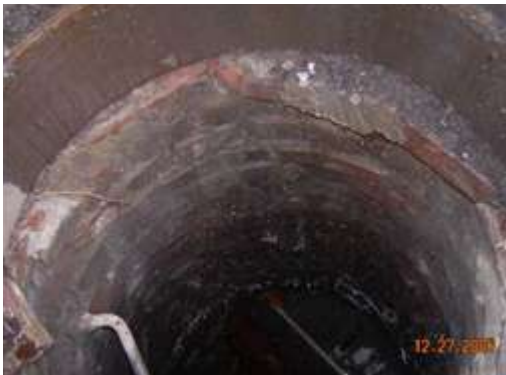
Defect

Frame leaks. Frame offset. Adjustment deterioration, root intrusion, loose brick and infiltration. Barrel root intrusion and

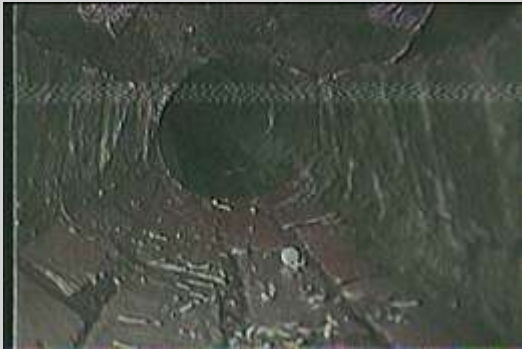
8 in. Circular Gravity Sewer
Pipe Out @ 12 O'Clock

Infiltration: **Evidence** Pipe Seal Cond: **Broken**

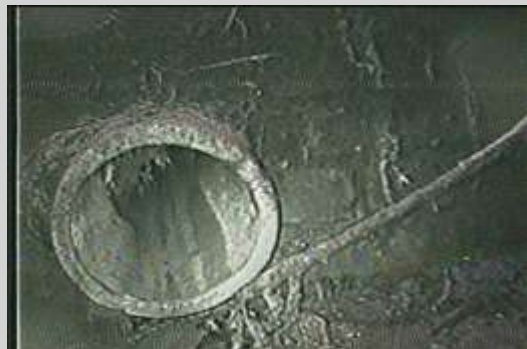
Pipe In @ 7 O'Clock

Barrel root intrusion and infiltration.

Pipe Seal Cond: **Roots**
